Manhole Inspection Summary

Manhole # S69M__029MH

Insp Date: **1/30/08 9:32 AM**

Location Address: **6600 O'Donnell St.**

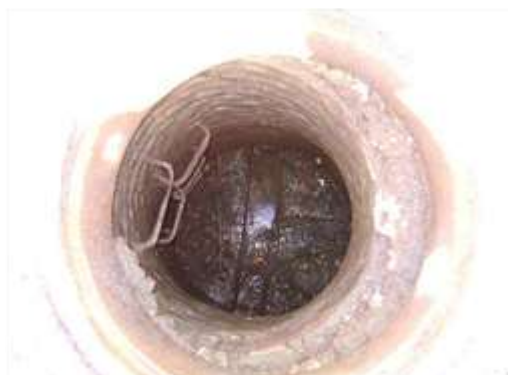
Defect 1

3 in. frame offset defect

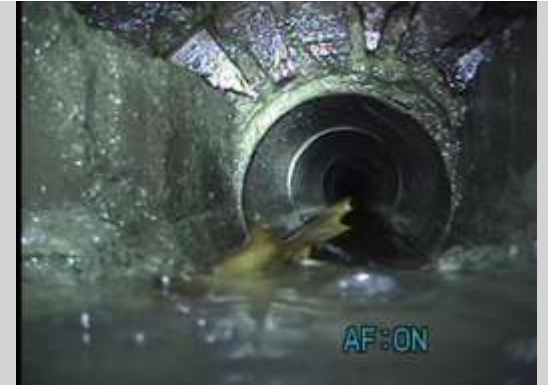
12 O'Clock Outflow

8 in. Circular Gravity Sewer
Pipe Out @ 12 O'Clock

Pipe Height: **8.4** (in.) Rod and Bar (Angled)
Pipe Material: **Clay** ☐ Pipe Lined
Invert Depth: **10.54** (ft.) Flow Characteristics: **Slow**
Deposits: ☐ None ☐ Mud ☒ **Sludge** ☐ Debris ☐ Grease
Silt Depth: **0.25** (in.) Deposits Extent: **Light**
Infiltration: **None** Pipe Seal Cond: **Sound**

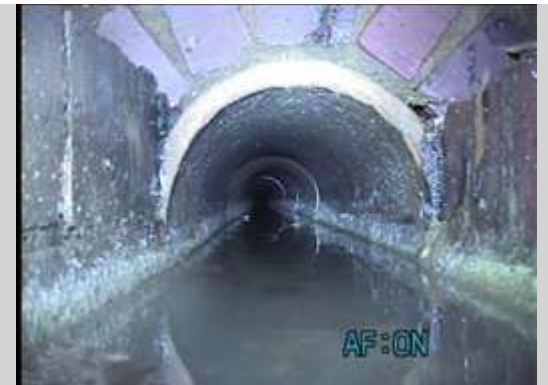
6 O'Clock Inflow

8 in. Circular Gravity Sewer
Pipe In @ 6 O'Clock

Pipe Height: **8.4** (in.) Rod and Bar (Angled)
Pipe Material: **Clay** ☐ Pipe Lined
Invert Depth: **10.54** (ft.) Flow Characteristics: **None**
Deposits: ☐ None ☐ Mud ☐ Sludge ☒ **Debris** ☐ Grease
Silt Depth: **0.5** (in.) Deposits Extent: **Medium**
Infiltration: **None** Pipe Seal Cond: **Sound**

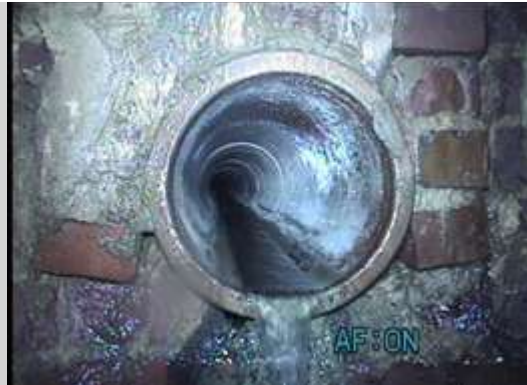
9 O'Clock Inflow

8 in. Circular Gravity Sewer

Pipe In @ 9 O'Clock

Deposits: ☒ None ☐ Mud ☐ ~~Sludge~~ ☐ **Debris** ☐ Grease

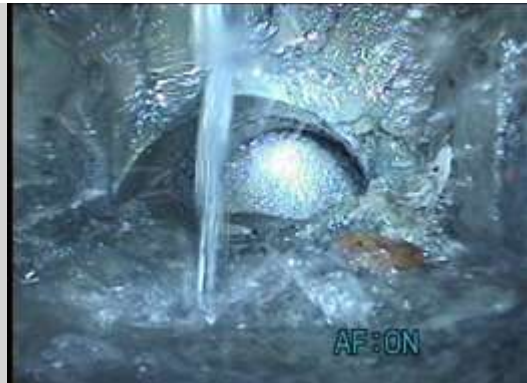
9 O'Clock Inflow

capped pipe

Deposits: ☐ None ☐ Mud ☒ ~~Sludge~~ ☒ **Debris** ☐ Grease

Silt Depth: **0.25** (in.) Deposits Extent: **Light**

Drop: **Outside** Rod and Bar

Drop Condition: **Clogged**

Connects To: **Stub connection / abandoned**
